Schwendel, Arved ORCID logoORCID:  
<https://orcid.org/0000-0003-2937-1748> and Cooper, Anthony (2021)  
Meander chute cutoff at an alluvial river facilitated by gypsum  
sinkholes. *Geomorphology*, 393 (107944). pp. 1-19.

# Meander chute cutoff at an alluvial river facilitated by gypsum sinkholes

Schwendel A. C.<sup>1</sup>, Cooper A. H.<sup>2</sup>

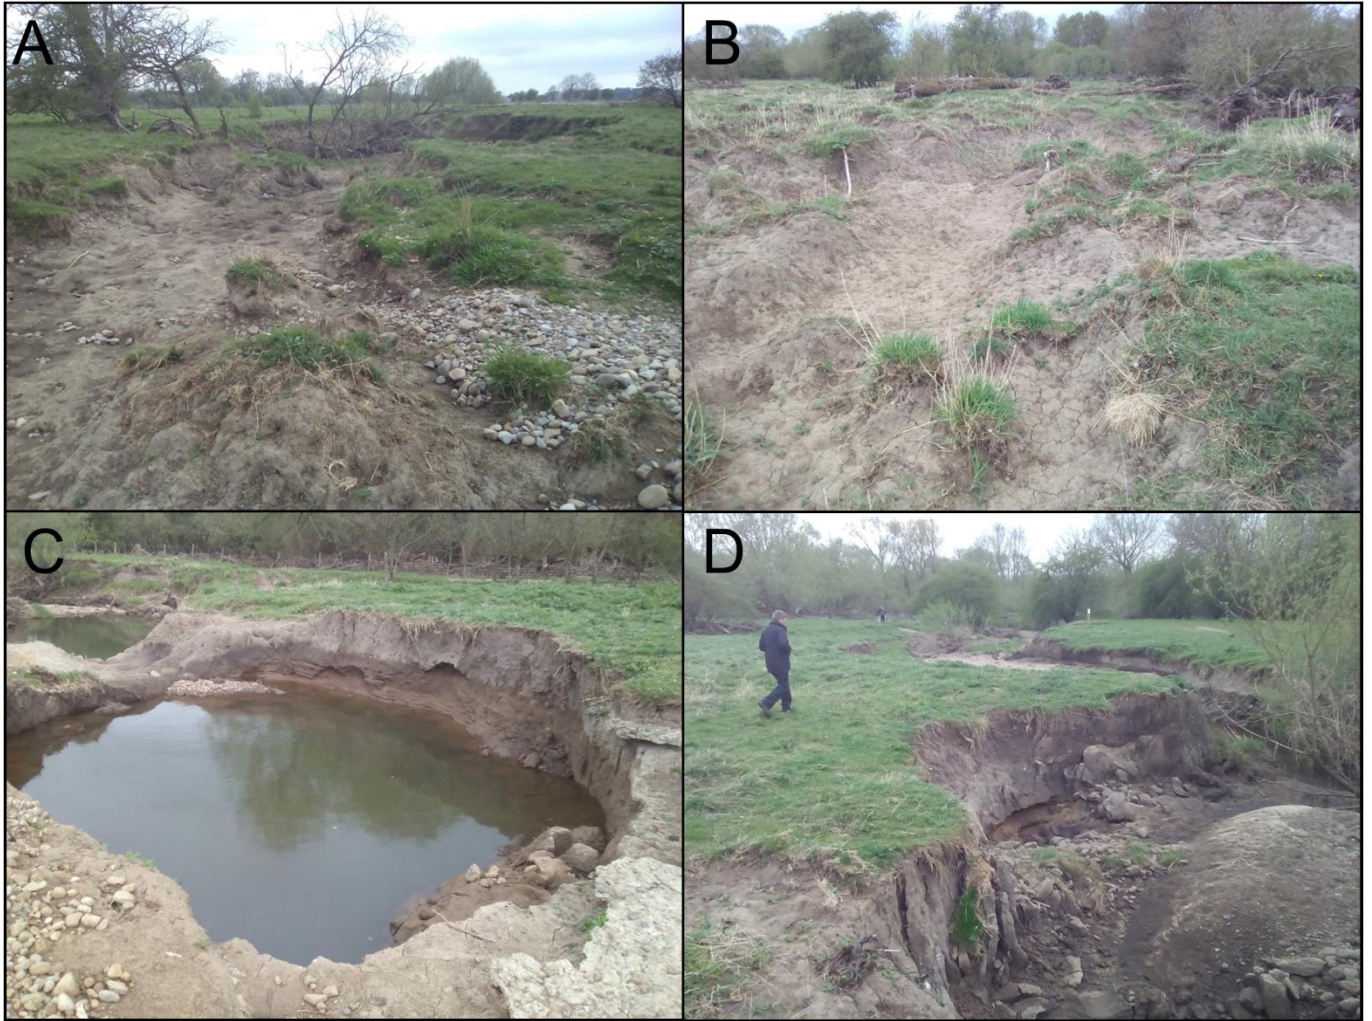
**Figure 10. Photos of Ripon Loop before cutoff (April 2019). (A) View in northerly direction towards sinkhole group G2 with superficial erosion channel from overbank flows in the foreground. (B) View in southerly direction from the head of the future chute channel towards sinkhole group G2 (same fallen tree in top right as visible in panel A) showing multi-thread superficial erosion scoured by flood waters since 2012. (C) New sinkhole subsided after 2015 associated with group G3 and group G5 in the background viewed from the same position as the photo in panel A but in south-westerly direction. Cobbles from overbank flows are visible at the downstream end and on floodplain in the foreground. Thick channel deposits are exposed on the edge of G5 while a thin cemented layer of cobbles at shallow depth is visible in the bottom right. (D) View in southerly direction on the chain of partly coalesced sinkhole groups G5 to G8 with cobbles deposited in the down-valley end of G6 and finer sediment in the southern part of G5 in the foreground. Sinkholes groups are defined in Fig. 8.**

Group G3 is first recorded as a pond on the 1892 dataset and shown with the same outline to 1957. The 1968 outline is smaller and may reflect partial filling of the hole. The 1986 data show an enlargement of the hole from 1968 and development of an irregular depression to the north which has formed into a larger depression on the 2001 lidar, while the main hole has expanded to the north-east. The 2009 lidar shows these two areas amalgamated into one large hollow, a pattern repeated on all the subsequent datasets with minor variations to 2019. Immediately west of the main hole a new sinkhole feature is visible on the 2017-2019 data, but not the 2015 lidar where only a narrow channel is shown, thus it appears to have subsided post this date (Fig. 10c).

embayments on the northern edge of some sinkholes (e.g. G2, G3 and G5) as well as narrow channels connecting them at a superficial level from 2015 show that headward incision during periods of overbank flow might have extended them as well (Fig. 10a,c). Gravel deposited by these overbank flows at the southern end of sinkholes has temporarily decreased observed sinkhole dimensions (e.g. G3, G5 and G8). By summer 2019 the sinkholes in the southern part of what became the cutoff channel (Fig. 2) had partially connected via headward erosion with low-level thresholds in between (Fig. 10c). As Ripon Loop has translated down-valley since the 1900s, the lower part of this chute channel has incised easily into relatively unconsolidated, less than 170 year old channel deposits (Fig. 2) which were well exposed in the sinkholes (Fig. 10c,d).

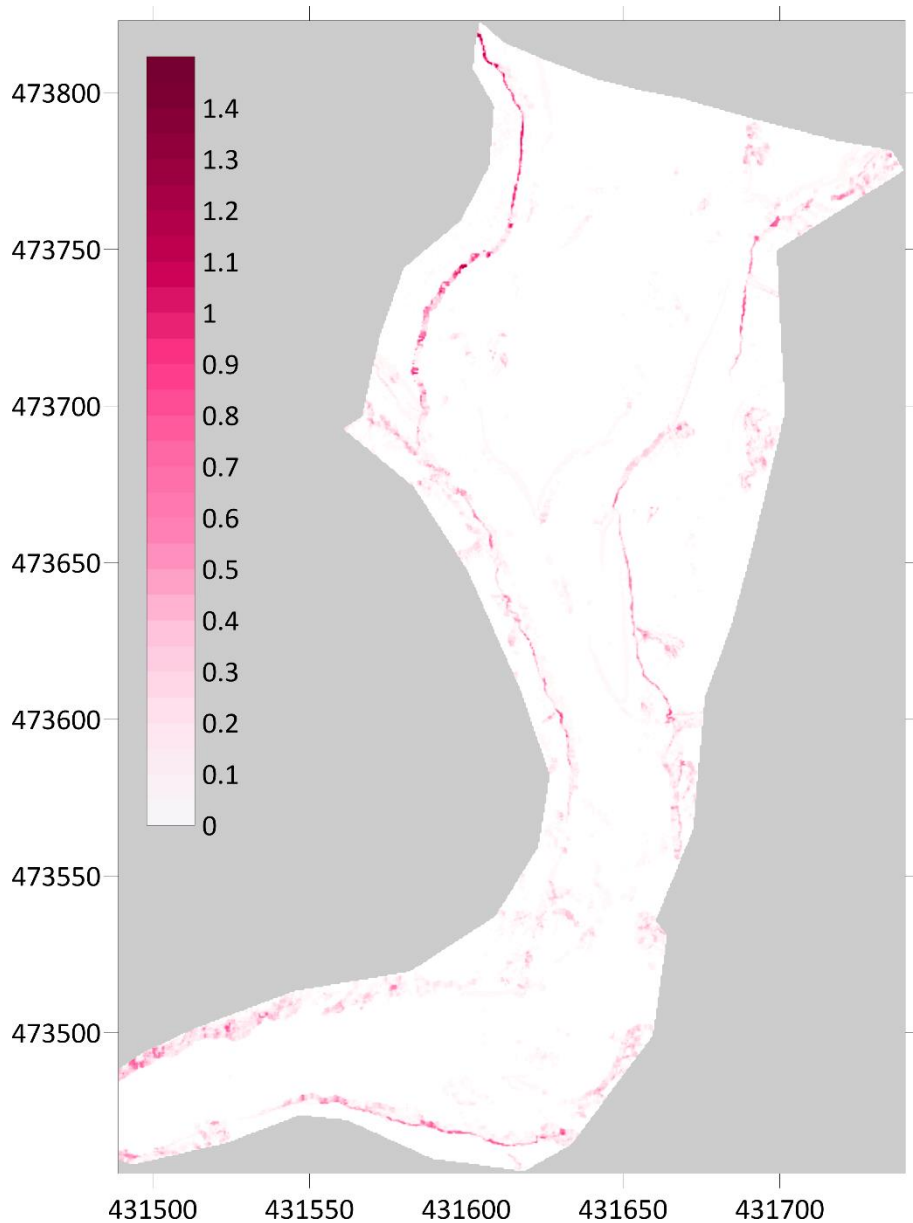
**Figure 12. Spatial distribution of the uncertainty to detect topographic change at 95% confidence level (given in metres and referred to as ‘level of detection’) that arises from the propagation of the spatially variable error associated with the used DEMs. British National Grid coordinates are in metres.**
